Service Bulletin – n. 05/2016

Reference: **D300 Canister Flush**

This service bulletin is to address the procedure for flushing out colorant contaminated with debris/sedimentation on D300 dispensers.

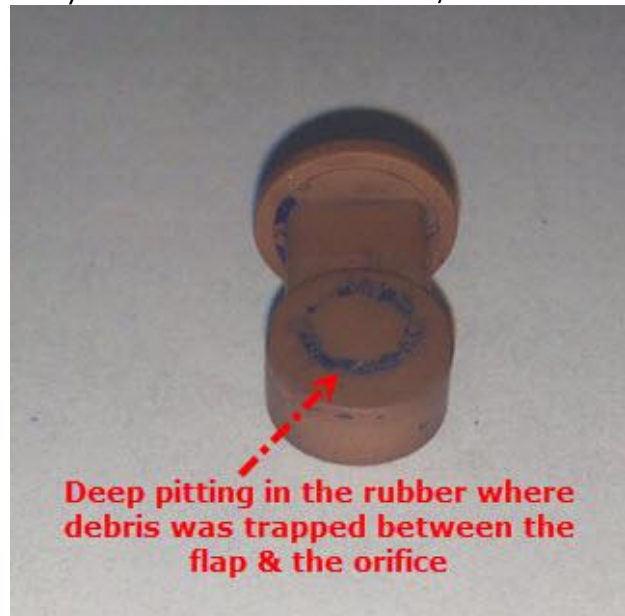
We have recently noted that on D300's there has been an increase in dripping valves. This, we believe, is due to pitting in the valve flapper caused by the aforementioned debris/sedimentation.

In order to prevent this damage from also being done to the replacement pump, it is recommended that when flushing the canister the technician **NOT DISPENSE UNFILTERED COLORANT OUT OF THE NEW PUMP.**

To empty the canister of the contaminated colorant;

- Detach the piping from the back of the pump & let the colorant drain into a container placed beneath the detached pipe.
- Once the bulk of the colorant is drained set to the side to be strained.
- Place a separate container under the pipe to catch the waste water from the canister flush.
- Then remove feed tube from the tank and flush completely to remove sediment from feed tube. ****be sure to thoroughly flush the canister & feed tube before replacing the piping to the new pump*****
- Once the flush is complete, replace the old damaged pump & reattach piping
- Strain / filter the colorant before refilling the canister.
- Proceed with priming & calibration procedure.
